# **WTB SNOW MELT SYSTEM INCIDENT REPORT**

## **Washington Trust Bank Snow Melt System Incident**

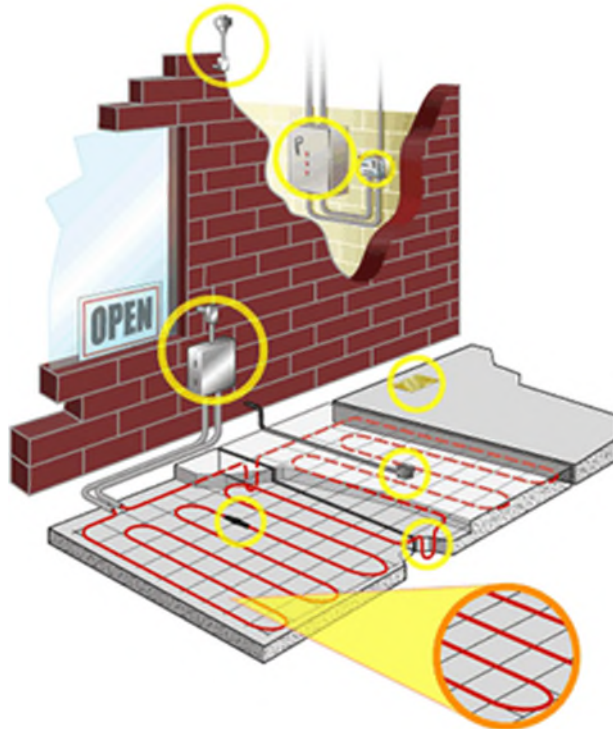
The system uses Mineral Insulated ("MI") cables, which consist of two copper conductors in an incoloy alloy tube with magnesium oxide insulation filling the tube. Incoloy is used as the sheath due to its high resistance to corrosion characteristic at high temperatures. Each cable is approximately 3/8" in diameter. The MI cables are cast into the concrete when the slab is poured. When expansion joints are crossed a "cold" (non-heating) jumper cable is spliced onto the ends of the two MI cables and a loop under the expansion joint is installed. The same is true of the power feed. A "cold" power feed cable is installed from the circuit breaker in the snow melt panel. Control of the snow melt panel is from a contactor that turns on or off the entire panel load. A simple diagram on how a typical snow melt system is laid out is provided for your reference:
